INPO 11-005  
November 2011

# **Special Report on the Nuclear Accident at the Fukushima Daiichi Nuclear Power Station**

Revision 0

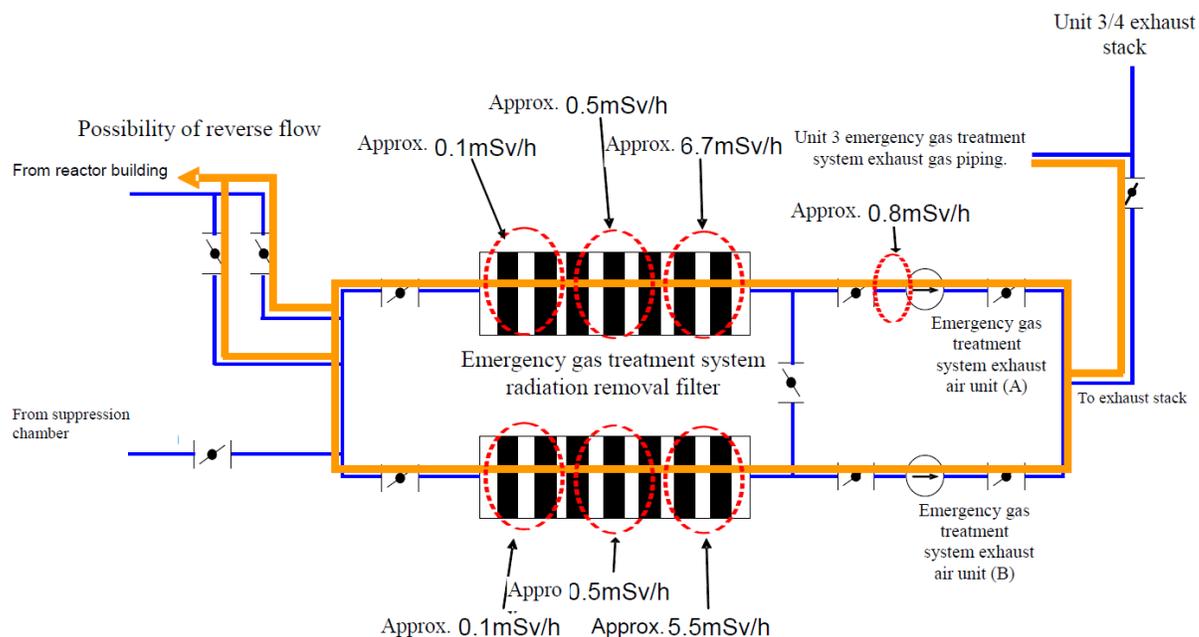
Figure 4.4-2 Unit 4 Standby Gas Treatment System Filter Survey Results

To confirm this theory, on August 25 TEPCO personnel performed radiation surveys on the Unit 4 SGTS filters. The survey results, shown in Figure 4.4-2, revealed higher radiation levels at the locations closer to Unit 3. These survey results support the conclusion that there was backflow from Unit 3 to Unit 4. Further inspections are needed to confirm this theory; but based on this information, it is postulated that the hydrogen explosion in the Unit 4 reactor building was caused by hydrogen from Unit 3.

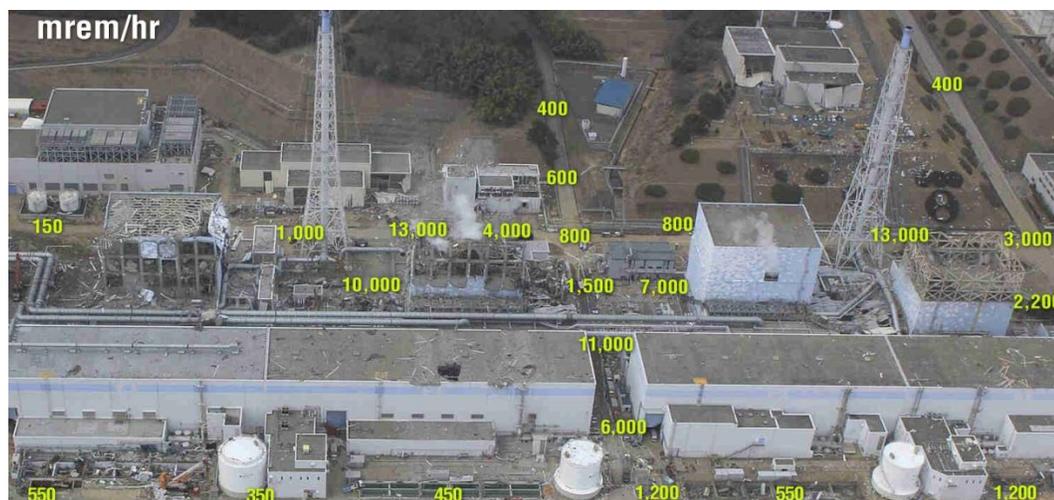
Figure 5.3-1 Site Dose Rates

On March 22 and 23, surveys of the airborne radioactivity and dose rates around the site began to be collected and documented. The dose rates are documented on Figure 5.3-1. Localized dose rates as high as 1,000 rem/hr (10 Sv/hr) were later discovered.

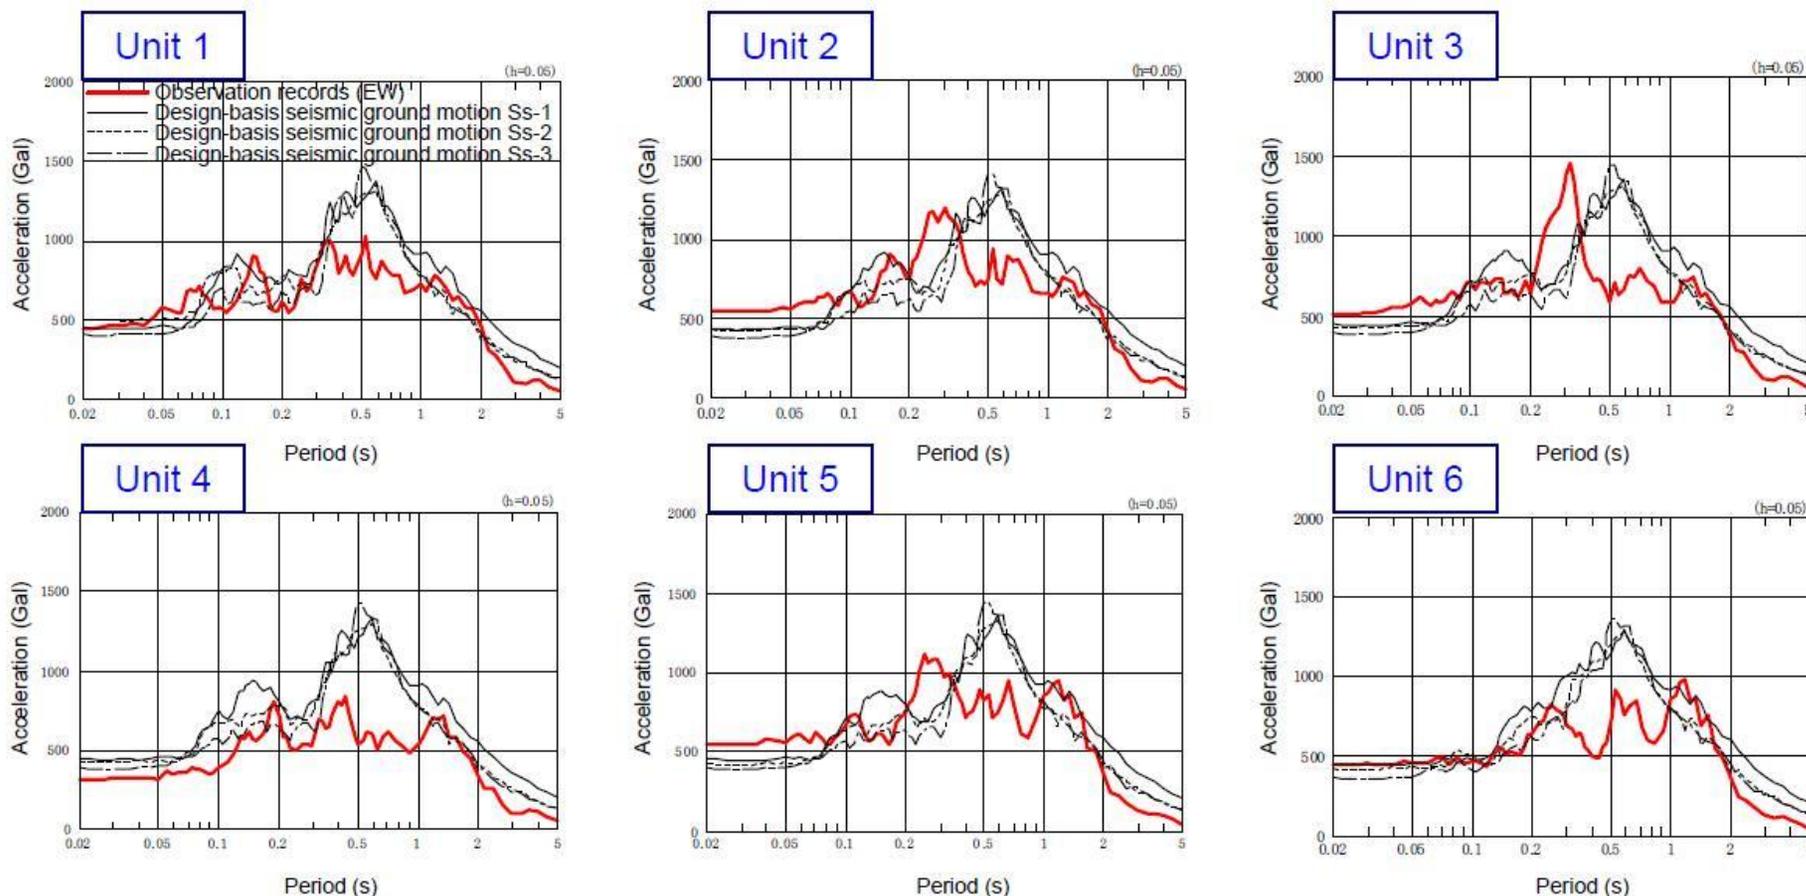
Figure 7.1-1 Preliminary Seismic Data

Graphs indicate the observed values as compared to the design basis seismic criteria.
